LOGO	<b>BSA CONTROL</b> ENVIRONMENTAL BIOSECURITY – INSPECTION - CONTROL	<b>Report number</b> <b>File number</b> <b>Laboratory number</b>	<b>20-015581</b> <b>29-20-0230</b> <b>20-1882-84</b>
------	--	--	--

## Malaga Transport Company EMT MÁLAGA

Continuous disinfection system validation

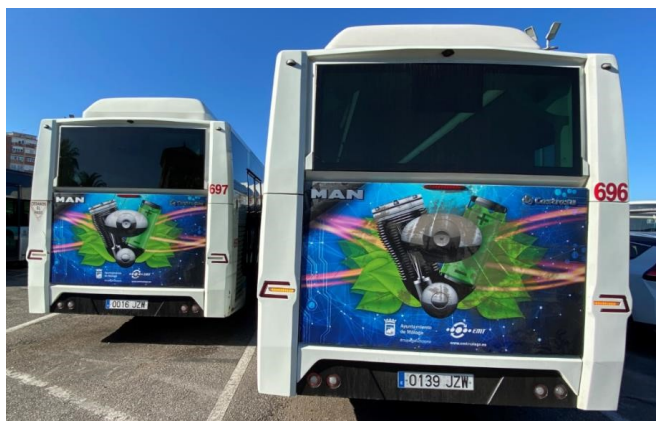
Bus 696 –	With disinfection equipment. 212 Passengers - Line 1 Disinfected with Ox-Virin
Bus 697 -	Without disinfection equipment. 206 Passengers - Line 1 Disinfected with Ox-Virin

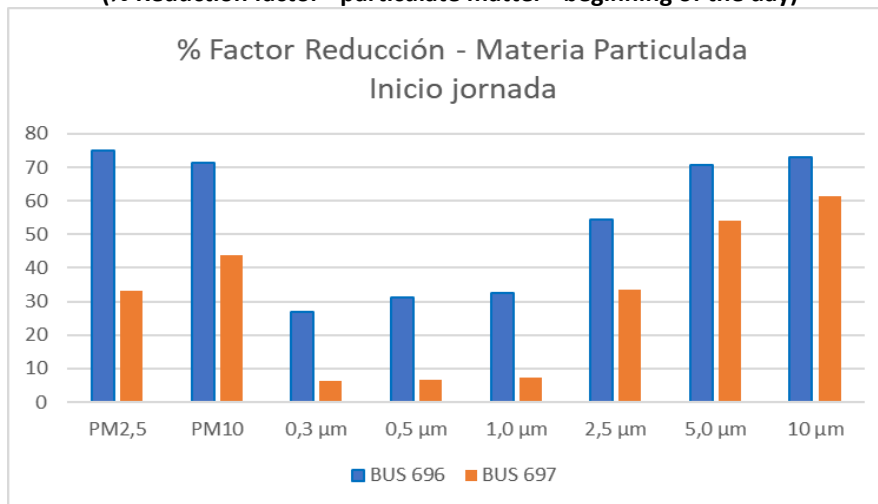
#### (% Reduction factor - particulate matter - beginning of the day)

The reduction factor of particulate matter in bus 696, equipped with a photocatalysis system, is appreciable, in comparison with the contrast bus (697), obtaining significant reduction results, both at the beginning and at the end of the day.

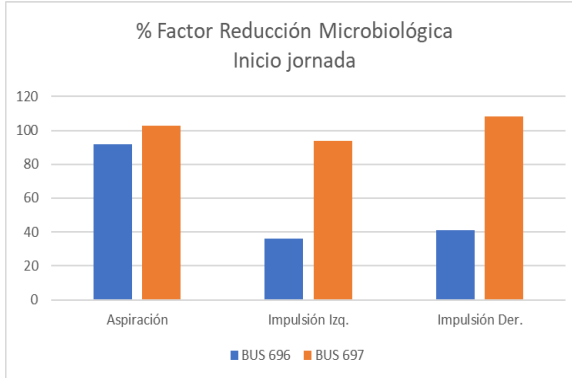
Microbiological reduction factor (beginning of the day)

The microbiological reduction factor in the environment is very acceptable, obtaining a great difference with respect to the contrast bus.

Average factor bacterial reduction - bus 696	- 57.19 %
Average factor bacterial reduction - bus 697	- 2.01 %
Average fungal reduction factor - bus 696:	- 67.53%

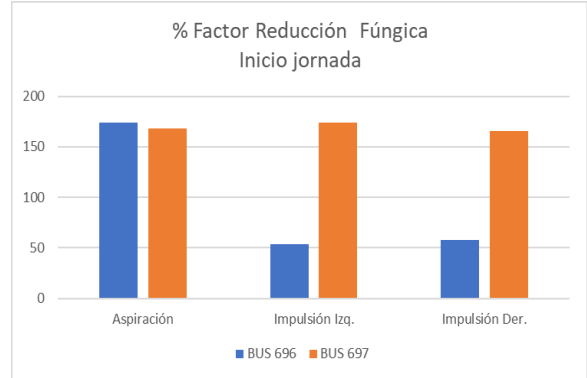
Fungal reduction factor (beginning of the day)

Average fungal reduction factor - bus 697: - 0.48 %
